Manhole Inspection Summary

Manhole # S37EE_002MH

Insp Date: **7/6/09 10:07 AM**

Location Address: **1100 FORREST ST**

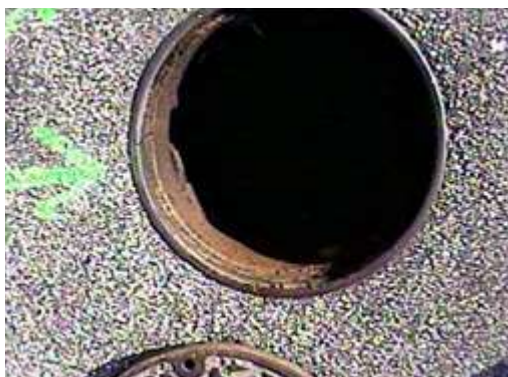
Defect 1

Frame Offset: **1** (in.) Condition: ☒ Sound ☐ Cracked ☐ Leaks

FRAME OFFSET

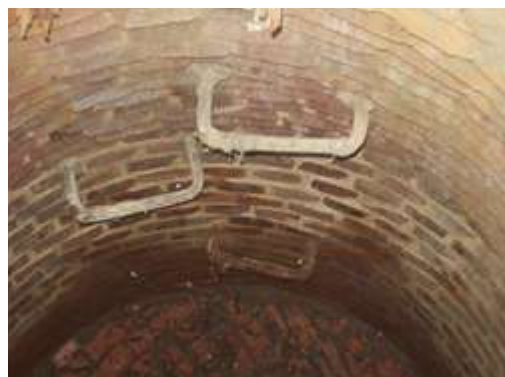
Defect 2

Steps Count: **4** Missing: **1** ☒ **Corroded**

CORRODED STEPS

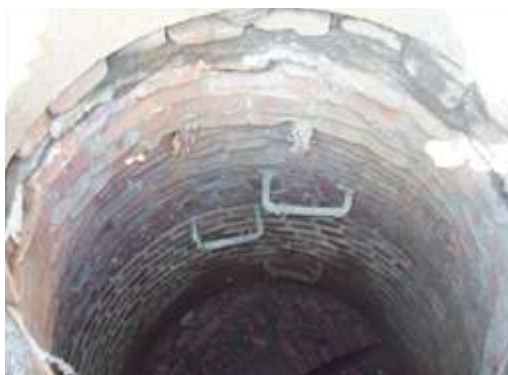
Defect 1

MISSING STEP

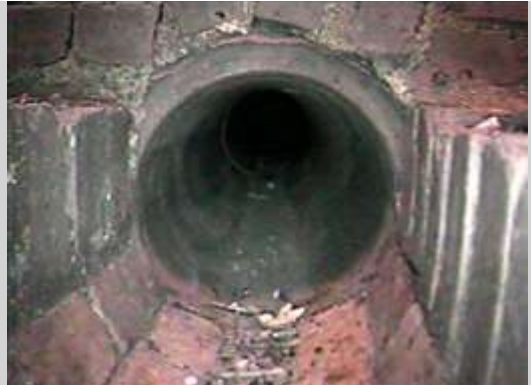
12 O'Clock Outflow

8 in. Circular Gravity Sewer
Pipe Out @ 12 O'Clock

Pipe Material: **Clay** ☐ Pipe Lined

Invert Depth: **8.09** (ft.) Flow Characteristics: **None**

Infiltration: **None** Pipe Seal Cond: **Sound**

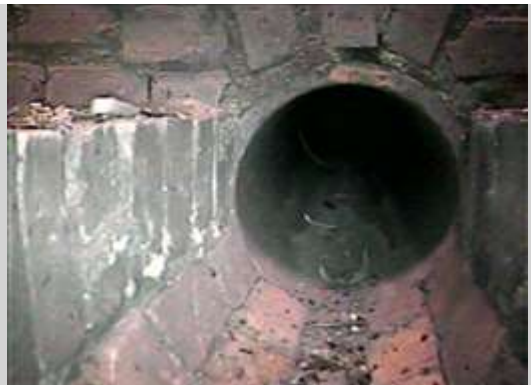
9 O'Clock Inflow

8 in. Circular Gravity Sewer
Pipe In @ 9 O'Clock

Pipe Material: **Clay** ☐ Pipe Lined

Invert Depth: **8.04** (ft.) Flow Characteristics: **None**

Infiltration: **None** Pipe Seal Cond: **Broken**
